# DEBRIS-FLOW HAZARDS IN AREAS AFFECTED BY THE JUNE 27, 1995

## STORM IN MADISON COUNTY, VIRGINIA

OPEN FILE REPORT 97-438

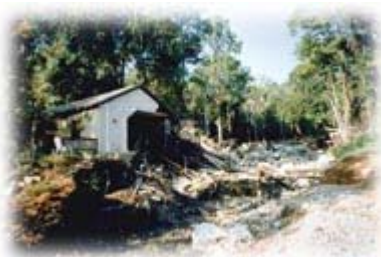
Time of impact 11:30-12:00 EDT  
(Home of J. Crosgrove)

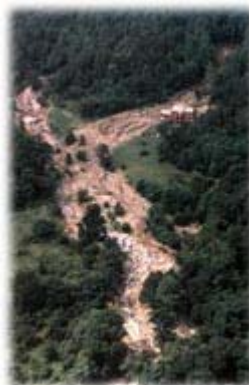
Time of impact 10:00-11:30 EDT  
(Home of L. Brown)

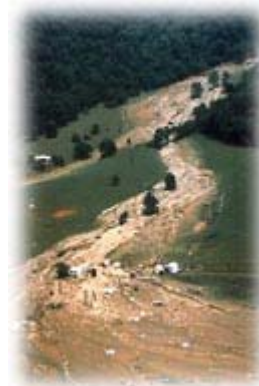
Times of impact 11:30-11:45 to 1:00  
EDT  
(Home of R. Lillard)

Multiple pulses of debris flows were observed in several channels and fans. Near Graves Mill a house was hit and moved by separate debris flows about 1.5 hours apart (Mr. Randall Lillard, oral commun., 8/28/95). An observer east of Graves Mill observed five surges of debris flows moving down a single channel with an estimated velocity of 20 miles per hour about fifteen minutes apart (Mr. Leighton Brown, oral commun., 10/10/95). The unknown amount of time between multiple pulses of debris flows in a channel poses hazards for escape and rescue.

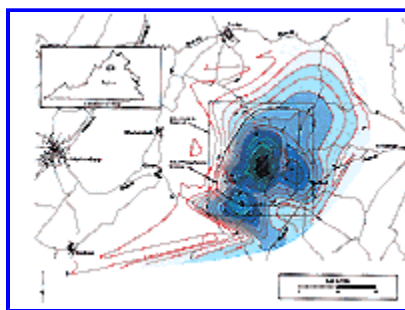
**figure 1** Location map of Madison, Virginia area and regional intensity of rainfall, shown by isohyets, and rain gage stations (149K size)

The Madison County area affected by the June 27, 1995 storm is within the upper drainage basin of the Rapidan River on the eastern flank of the Blue Ridge mountains. The topography is irregular with many subsidiary ridges extending several miles away from the Blue Ridge separating well defined hollows with small tributaries. [Figure 2](#) is a digital shaded relief map of the area with isohyets from the storm shown in red. The maximum 30 inch isohyet is centered over the small community of Graves Mill.

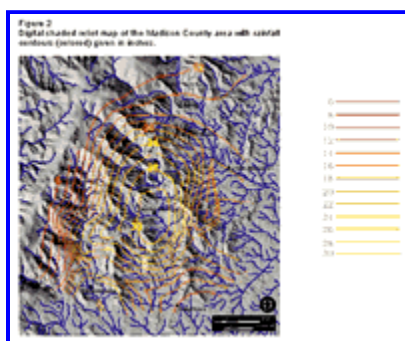
**figure 2** Digital shaded relief map of the Madison County area with rainfall contours (red) given in inches (189K size)

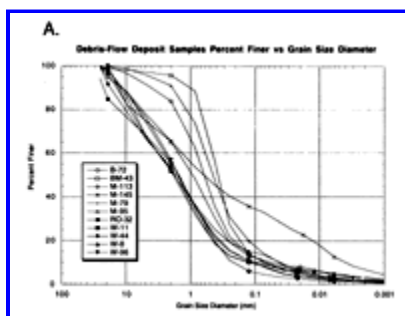
[figure 3A](#) Grain size distribution of ten samples of matrix from depositional fans

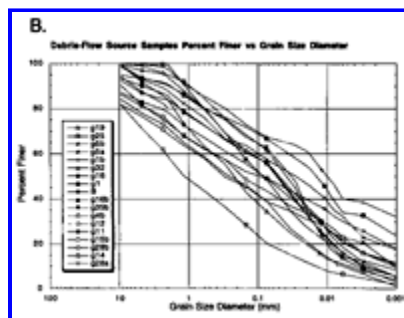
[figure 3B](#) Grain size distribution of eighteen samples of matrix from source areas

Although bedrock lithology did not appear to influence the initiation of debris flows, the granitic composition of the bedrock provided an abundance of quartz sand in the soil and weathered colluvium. Coarse-grained materials (gravel and sand-sized-particles) are much more abundant than fine-grained materials (silt and clay) in the matrix of the depositional fans of the debris flows. [Figure 3A](#) shows the distribution of grain sizes in a composite of ten samples of matrix all taken from fans in the Graves Mill area. The percentage of fines (silt and clay) in the matrix of Madison County debris flows was determined by mechanical analyses to generally range from 8 to 14%; this is lower than the 10-20 percentage from many debris flows worldwide (Costa, 1984). The clay-sized fraction of the Madison County samples ranged only from 2-3%, which is in the lower range of values commonly reported for debris flows. Because the clay reduces permeability, prevents rapid dissipation of pore pressure, and greatly increases mobility, the mobility of debris flows is highly dependent on the presence of even 1-2% clay in the slurry (Costa, 1984). The debris flows of Madison County did not travel more than 1-1.5 miles partly because of the low clay content of the matrix. [Figure 3B](#) shows the distribution of grain sizes in a composite of eighteen samples all taken from source areas of debris flows in the Graves Mill area. These samples of percentage of fines (silt and clay) range from about 7-50%. The much higher percentage of fines from source areas reflects the origin of debris flows as soil slips on colluvium or weathered bedrock. The clay-rich soils, forming the initial matrix of the debris flows, were rapidly diluted down slope as the debris flows swept deeper and deeper through the surficial materials, well below the clay-rich A horizon of the soil.

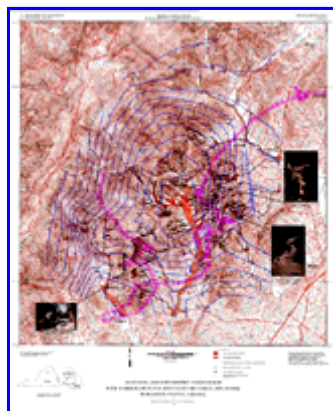
[Plate 1](#) Isohyetal and Topographic Map with Debris Flow and Flood Effects of the June 27, 1995, Storm in Madison County, Virginia

Most debris flows initiate as shallow landslides (soil, debris or rock slides) on steep slopes with relatively thin residual or colluvial soils. Slope steepness influences the susceptibility of hillslopes to initial sliding because of the limited strength of soils, particularly under saturated conditions during heavy rainfall. As described by Wieczorek and others (1996), most of the shallow landslides during the 1995 storm rapidly changed into debris flows which moved down preexisting channels onto fans as the slopes declined from about 30 degrees to about 6 degrees. Measurements of debris-flow source areas, channels and deposits on fans are listed in [Table 1a](#), [Table 1b](#) and [Table 1c](#), and are keyed to a map showing these features on [Plate 1](#).

Areas traversed by debris flows and floods in June, 1995, are taken from [Plate 1](#). The extent of alluvial sediments defining the existing flood plain, and areas underlain by prehistoric debris-flow deposits were determined by inspection of 1:24,000-scale topographic maps and by field observations.

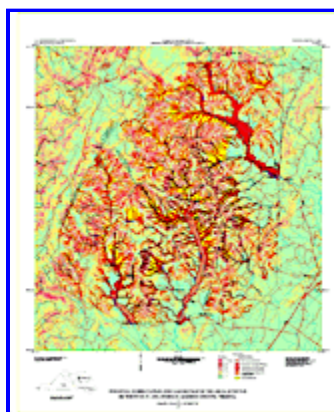
[Plate 2](#) Debris Flow/Flood Hazard Map of the Area Affected by the June 27, 1995, Storm in Madison County, Virginia

A generalized hazard map for the Madison County area is presented as [Plate 2](#). Identification of the potential for hazards is based on the following criteria:

1. areas traversed by the debris flows from the June, 1995 event
2. areas flooded by the June, 1995 event
3. areas identified by the distribution of alluvial sediments deposited by earlier floods
4. areas underlain by prehistoric debris-flow deposits
5. areas underlain by slopes greater than 26 degrees
6. channels defined by actual or potential flow paths having an origin on slopes greater than 26 degrees and delineated with a buffer 10 feet in elevation above the channel

[Plate 2](#) uses colors to depict slope values. Slope, aspect, and elevation were derived for 10-meter grid cells from a digital terrain model created from standard USGS digital line graph (DLG) data for the contours of the 7.5' quadrangles included in the study area. The 10-meter cell size is probably as small as one can expect to accurately use for a

Active and intermittent stream channels draining slopes steeper than 26 degrees constitute the principal pathways for debris flows and therefore provide a guide for predictions of the transport of future ground failures and debris flows. [Plate 2](#) shows the areas defined by the stream channels draining these steeper slopes. All potential stream pathways are delineated with a buffer point of origin, down slope to the terminus of the debris flow fan or its intersection with flood waters within a higher order drainage. The potential pathways show the results of modeling the lateral extent that would be occupied if a debris-flow front 10 feet high moved through existing drainage channels or potential drainage channels below areas where slopes are steep enough for debris flows to be initiated by high rainfall. The 10-foot flow depth represents the average of the estimated depths for flows in the channels observed in the field. Actual and potential flow paths were derived by using ARC/INFO GRID functions designed for use in hydrologic modeling. The elevation grid provided a principal basis for deriving grids representing flow directions, flow accumulation, stream lines and stream order, which were utilized to delineate the areas of potential debris-flow hazard.

The data shown on Plate 2 at 1:24,000-scale are not sufficiently detailed for the results of these analyses to be directly applied to specific site evaluations. The results should serve, however, to identify areas where state and county officials may wish to adopt and implement grading code measures (such as those outlined in Chapter 70 of the Uniform Building Code) for the protection of inhabitants of the county. It should also help to serve emergency response officials to identify areas likely to have the greatest need for services when National Weather Service (NWS) forecasts warn that extreme rainfall events are imminent. The procedures used to make the map are probably valid for application to other parts of the Blue Ridge, and for most other parts of the southern and central Appalachian Mountains where digital line graph data for the contours of USGS 1/24,000-scale 7.5' topographic maps are available.

The procedures used to prepare the hazard map of the Madison County area ([Plate 2](#)) can be applied toward consideration of potential hazards in other parts of the Blue Ridge and, more generally, along the eastern Appalachian Mountain front from Pennsylvania to Alabama. Recurrence for a debris-flow event in a small area may be one event in three or four thousand years as suggested by Kochel (1987) for the Nelson County, Virginia area. The recurrence interval for debris-flow events will decrease when considering much larger areas. The Virginia State government and its Office of Emergency Services has a responsibility for an area that may have a recurrence interval for debris-flow events of about one event in every ten to twenty years; the Federal Emergency Management Agency has a still larger area of concern, an area that may have a recurrence interval for debris-flow events of about one event in every three to five years in the central and southern Appalachian Mountains based on data from Clark (1987). Over such a broad area encompassing some 160,000 square miles several general principals should remain applicable in considering the potential for the occurrence of debris flows.
